# Manhole Inspection Summary

Manhole # S47G\_\_019MH

Insp Date: **5/1/08 10:06 AM**

**Location** Address: **202 S Collington Av**

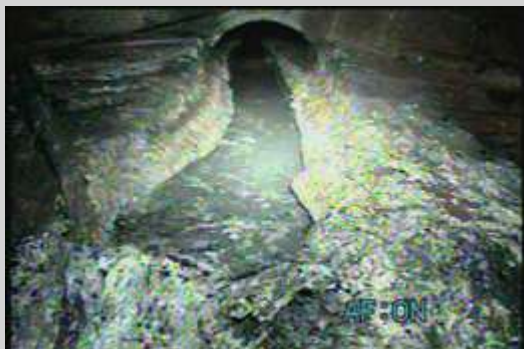
5 O'Clock Inflow

8 in. Circular Gravity Sewer  
Pipe In @ 5 O'Clock

Pipe Height: 0 (in.) Direct

Pipe Material: **Clay** ☐ Pipe Lined

Infiltration: **None** Pipe Seal Cond: **Unknown**
